Advantages of Concrete Silos **Over** **Metal Welded or Bolted Silos**

TYPICAL FLY ASH SILO Union Construction COMPARISON CHART

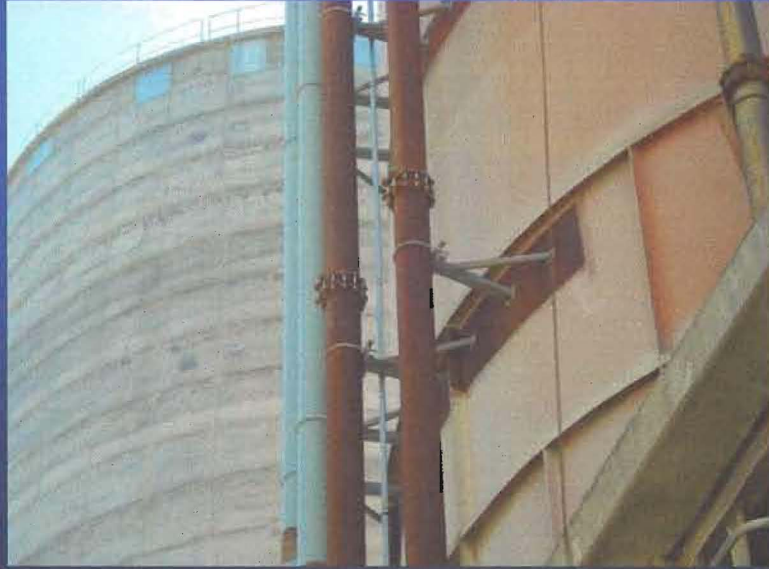
Welded steel silo needed stiffener to
receive new fill pipe

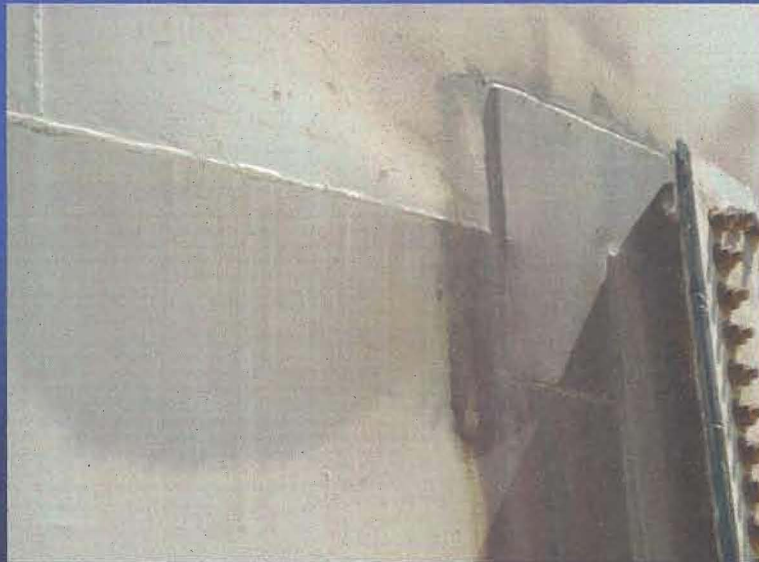
Bending of welded steel silo
wall and new stiffener

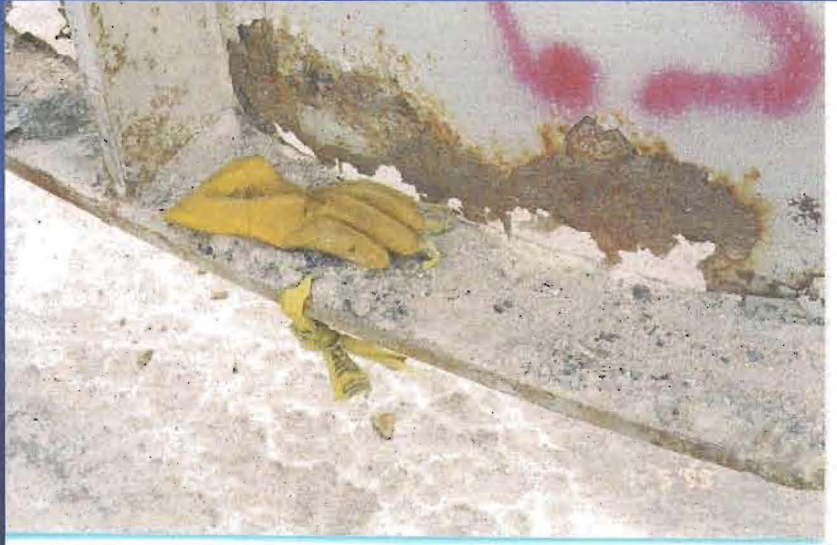
Corrosion just above
hopper/cylinder junction that
caused hopper to drop off

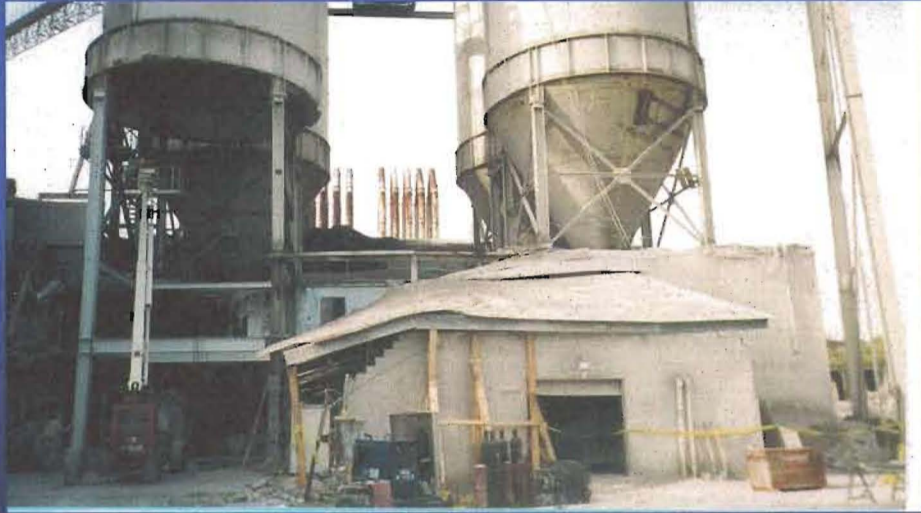
Failure of welded steel conical hopper storing limestone

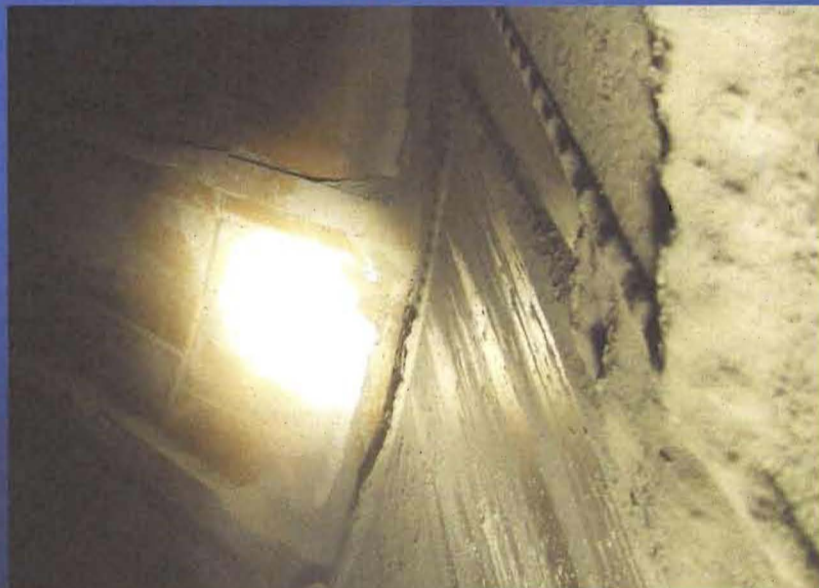
Water leaking inside new bolted steel silo

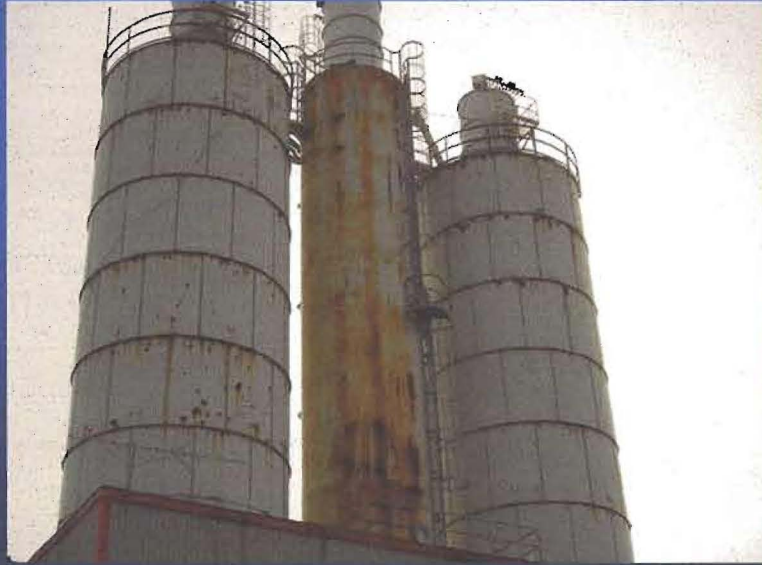
Steel silos need painting.
Painting delayed due to high cost.

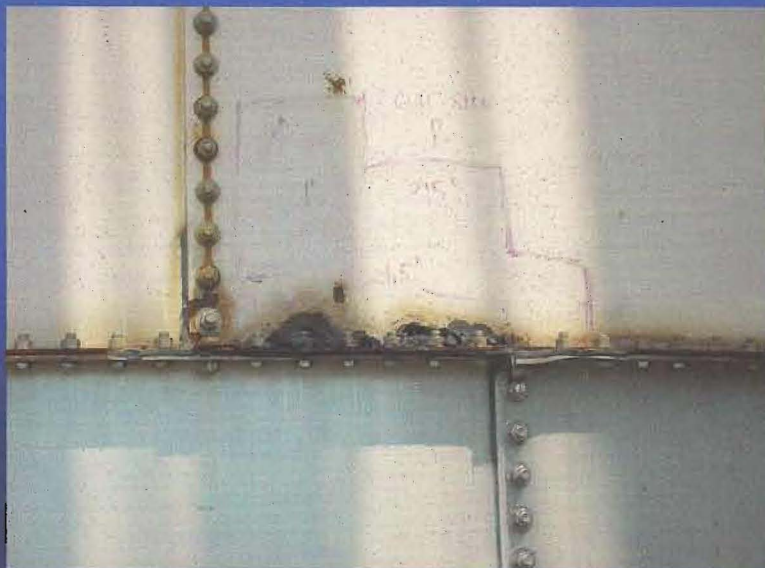
Holes in bolted steel silo
due to corrosion
